One block from the White House – leaker identified and caught on video

In order to detect possible leakage and evaluate the general pipeline condition, the District of Columbia Water and Sewer Authority, DC Water, decided to optically and acoustically inspect one of the oldest parts of the Washington D.C.'s drinking water network.

A 670m (2,200ft) section of a cement mortar lined cast iron main - installed in 1888 - was subject to be investigated by MTA Pipe-Inspector® multisensory technology.

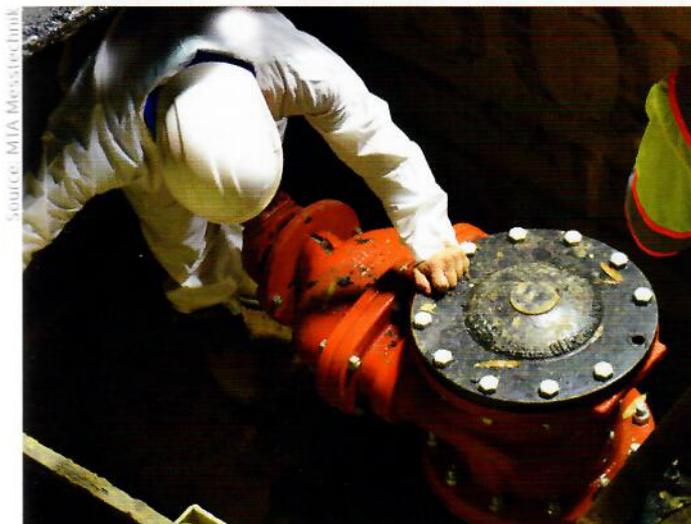
Start access sluice valve installed by DC Water forces

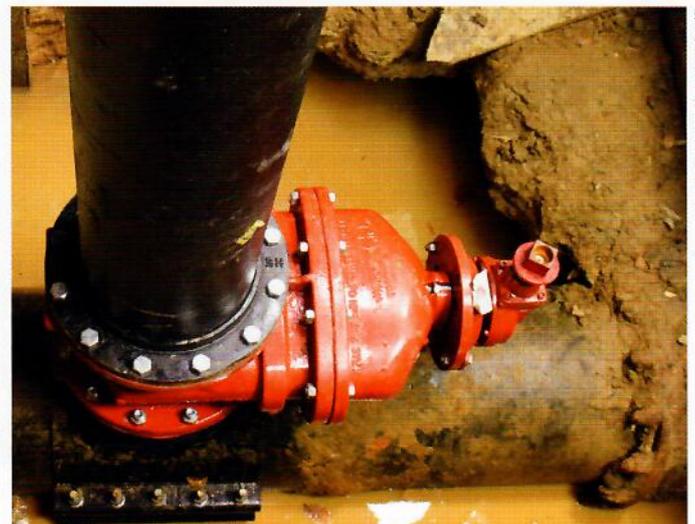
Retrieval access sluice valve installed with riser piece

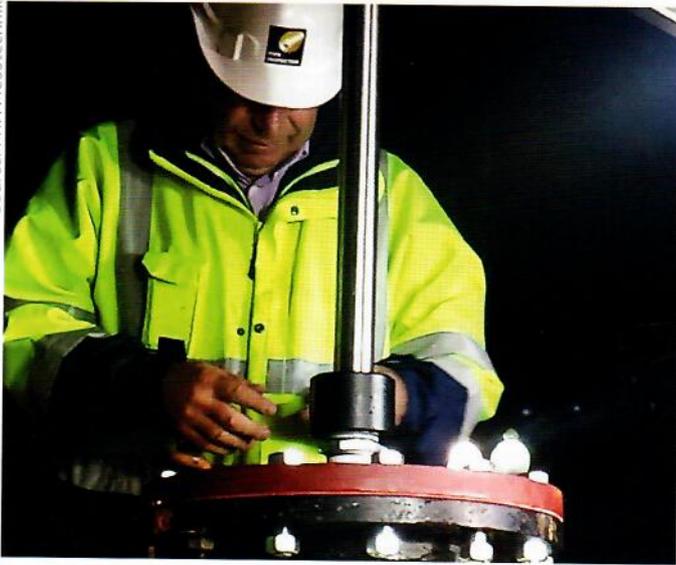
Plunging sleeve connection typical at both access points

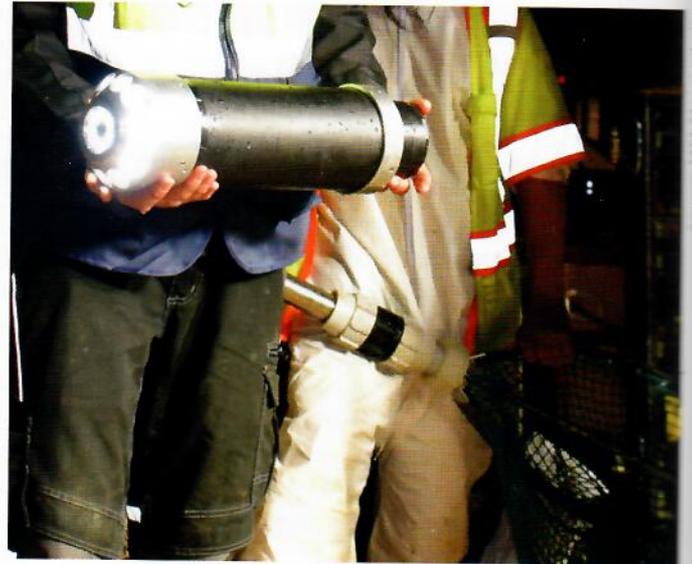
MTA Pipe-Inspector DN125 continues to operate after extraction until turned off and on-board data extracted to computer for immediate video review and data analysis
