# Detection of Minor Leakage in a Drinking Water Power Plant Pipeline

Project in the South Tyrolean community Mals in Italy

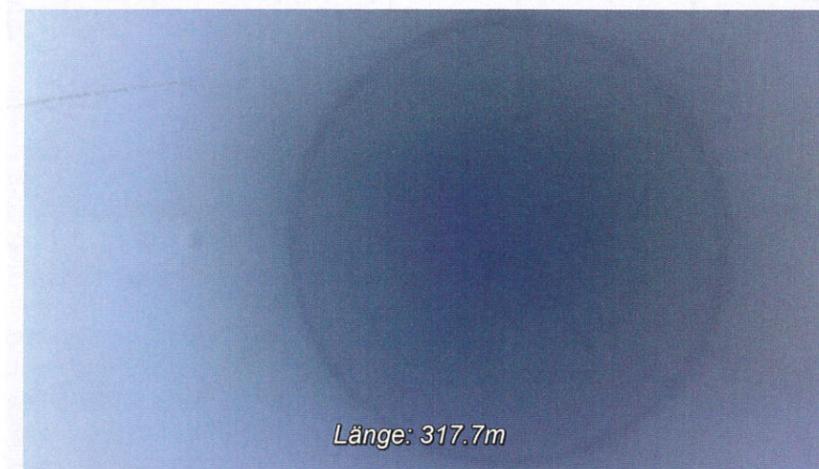
Figure 9: Video image pipe interior

Based on the pressure test results, a water loss of 3.9 l/h has been calculated already in the run-up. This value suggested itself, that imaging techniques wouldn't deliver significant results allowing the optical positioning at such low loss rates. The video data analysis finally confirmed this assumption (Figure 9).

The acoustic analysis identified for instance a clear leak noise at position 317.7 m, although the corresponding

images of the affected area yielded no visible evidence (Figure 9 and 10).

A control inspection of the damaged area using geophone and correlator could not confirm the measurement results delivered by Pipe-Inspector. Once the damage protocol and video data have been sent to the customer, he arranged the excavation at the appropriate position. A subsequent visual pipeline inspection from the outside showed a 100% hit accuracy of the acoustic Pipe-Inspector measurements. The cause of the leak noise was finally elicited as damaged gasket in a sleeve connection. Two other leaks that were identified during the evaluation of the acoustic data, also turned out to be pipe connection problems.

The time and financial cost of the excavation to expose the affected area could be kept to a minimum thanks to the exact lengths indicated by the Pipe-Inspector system. Due to the test results quality, the necessary repair work could take place very quickly, which was the requirement for a repeated pressure test, necessary for the pipeline's commissioning. The total time frame from the arrival to the actual transmission of the evaluated inspection results to the customer was less than three working days.
