Detection of Minor Leakage in a Drinking Water Power Plant Pipeline

Project in the South Tyrolean community Mals in Italy

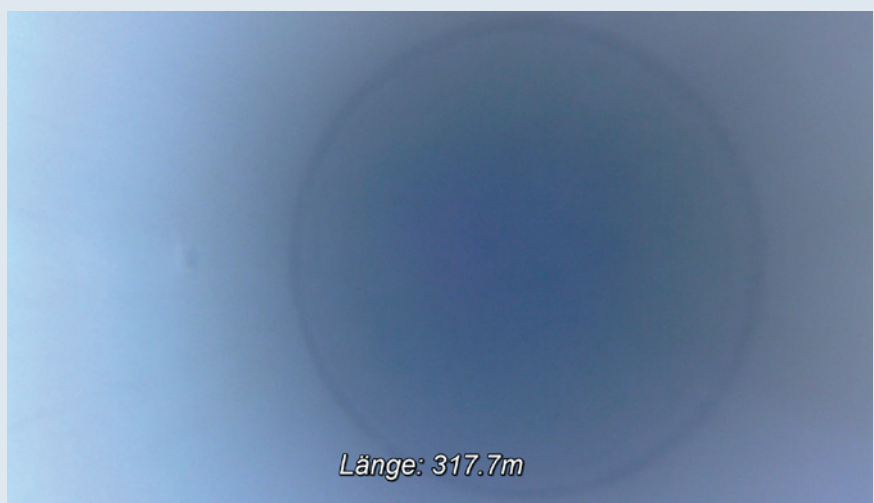
Figure 9: Video image pipe interior

Based on the pressure test results, a water loss of 3.9 l/h has been calculated already in the run-up. This value suggested itself, that imaging techniques wouldn't deliver significant results allowing the optical positioning at such low loss rates. The video data analysis finally confirmed this assumption. (Figure 9)

The acoustic analysis identified for instance a clear leak noise at position 317.7 m, although the corresponding

images of the affected area yielded no visible evidence. (Figure 9 and 10)
