# Detection of Minor Leakage in a Drinking Water Power Plant Pipeline

Project in the South Tyrolean community Mals in Italy

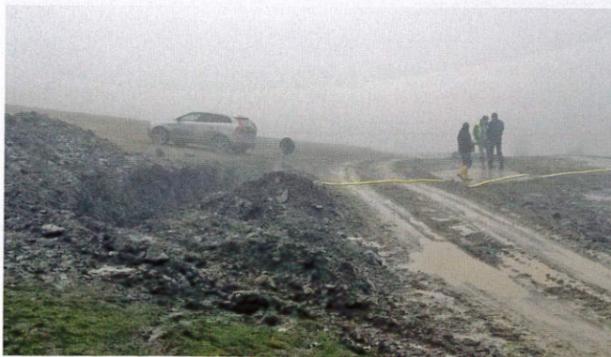
The affected ductile cast iron pipeline, DN 200, is located outside the settlement area in mountain terrain at about 2,000 m above sea level. Access is possible only via unpaved paths. The newly constructed pipeline was designed to replace the existing potable water pipeline in need of renovation and to feed a newly built small hydropower plant. The total length of the pipeline section to be inspected with multiple 22° bends was 630 m, its operating pressure 30 bar (Figure 1).

Figure 1: Site in over 2,000 m above sea level

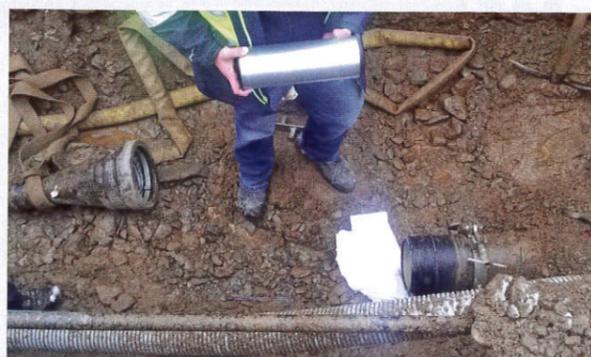
Figure 2: Pipe-Inspector launch

Since the pipeline was already divided and separated into separate sections for previous partial pressure tests, there was no additional expenditure for the inspection tool's introduction and removal (Figure 2).

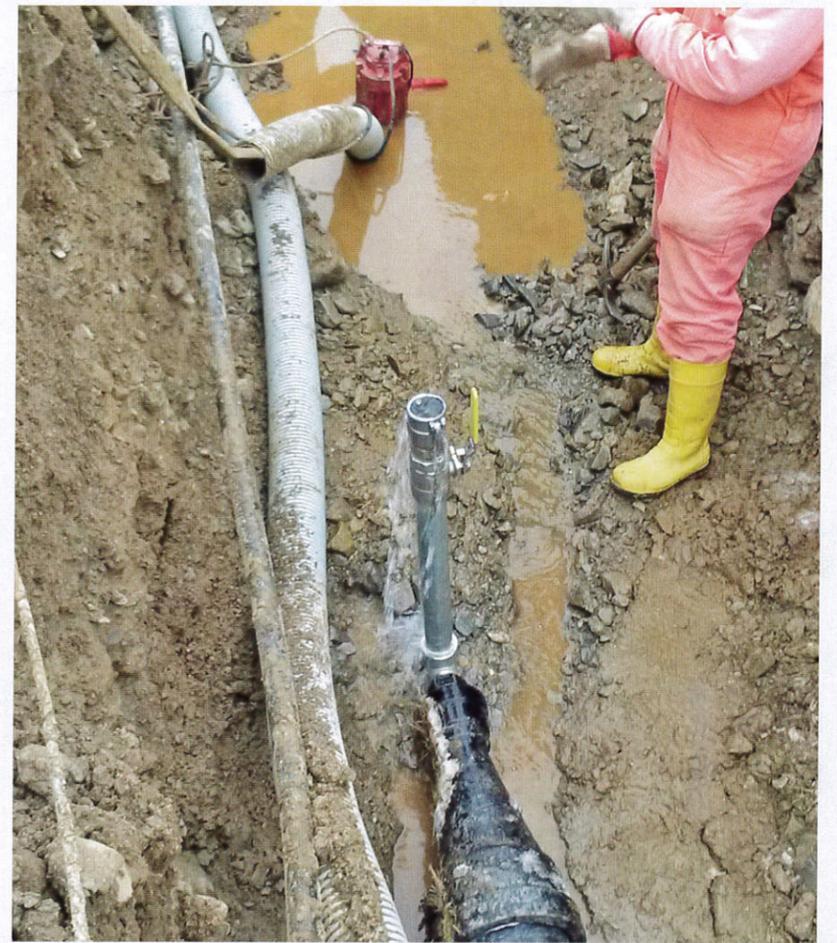
The Pipe-Inspector device was positioned at a defined starting point in the emptied pipeline and a special locking piece was mounted, furnished with a 90° upstanding water connection point. In a next step, the pipeline was filled with water at the end point of the pipeline section to be inspected and subsequently vented to prevent air pockets in the pipeline, which may reduce the quality of the optical inspection results (Figure 3).

Figure 3: Starting point with water connection point

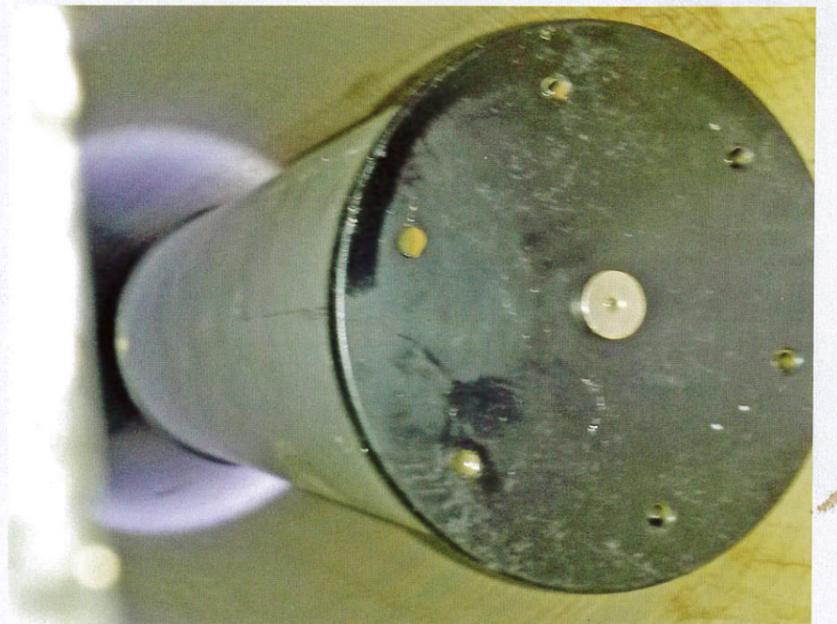
In order to perform the inspection under operating conditions, the pipeline was applied with 30 bar water pressure at the inspection start point, so that the Pipe-Inspector, driven by the media stream, began to move, and the inspection process was started (Figure 4).

Figure 4: Pipe-Inspector position at starting point

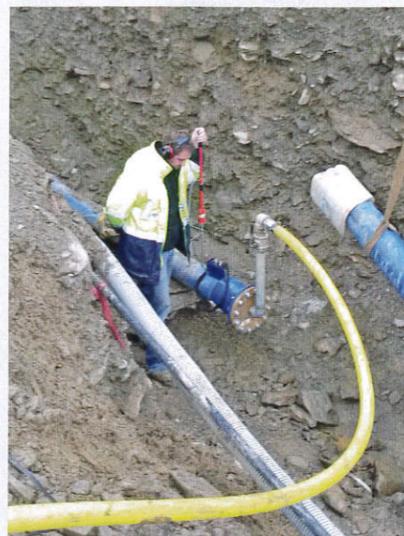
The flow rate regulation was achieved by partially opening a valve at the end point of the inspection route (Figure 5).

Figure 5: Inspection section end point

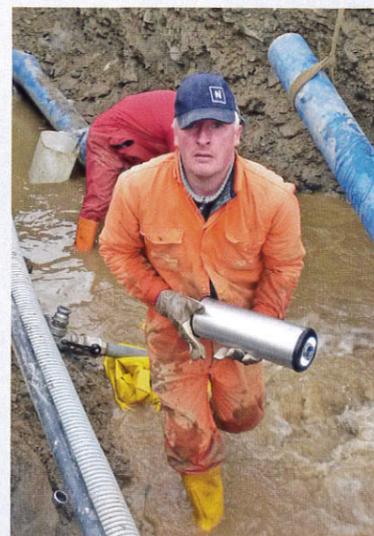
After 28 min the device reached the end point of the 630 m long inspection section and was taken out after emptying the line (Figure 6).

Figure 6: Pipe-Inspector after retrieval

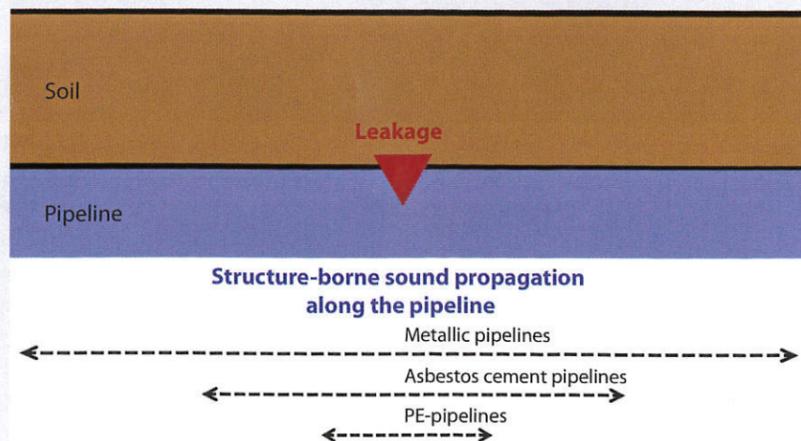
Figure 7: Structure-borne sound propagation

Another method, the leak detection using tracer gas, which is a hydrogen-nitrogen mixture, could not be applied in this project. The reasons were mainly the high financial cost, since for the 630 m long pipeline section with 30 bar pressure would need large amounts of gas. In addition, the safety effort is substantial and costly as well (Figure 7).

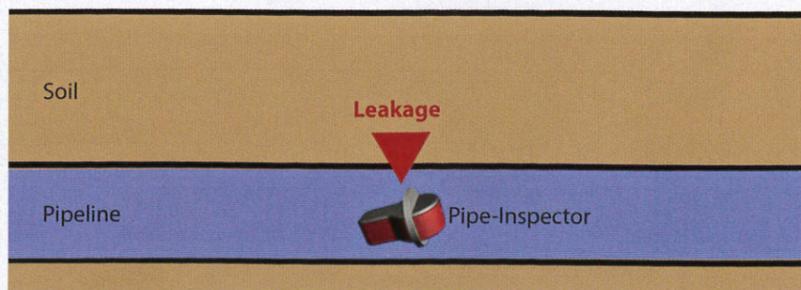
Figure 8: Leak detection by means of Pipe-Inspector

Pipe-Inspector follows a different method approach, in which the recording of the sound leakage takes place directly in the interior of the pipeline. Thus the detection of micro-leakages is also possible, since the system is not depending on the specific structure-borne sound properties of the pipeline's material (Figure 8).

Battery powered and cable-less, Pipe-Inspector floats freely in the media flow of the pipeline system (Figure 8). Therefore, it necessarily passes each defect or leakage, recording discharge sounds directly on site. Because of this fact, the method is especially suitable for minor leakages in pipelines under high pressure. Thanks to the automatic operating pressure recording in the inspected pipeline section, it is possible to record real data for the first time.
